⑥ National Dam Safety Program,
Lake Meade Dam, Susquehanna River Basin,
Commonwealth of Pennsylvania, Adams
County (NDS-PA-331). Phase I
Inspection Report.

LAKE MEADE DAM

INVENTORY NUMBER NDS PA-331

PHASE I INSPECTION REPORT

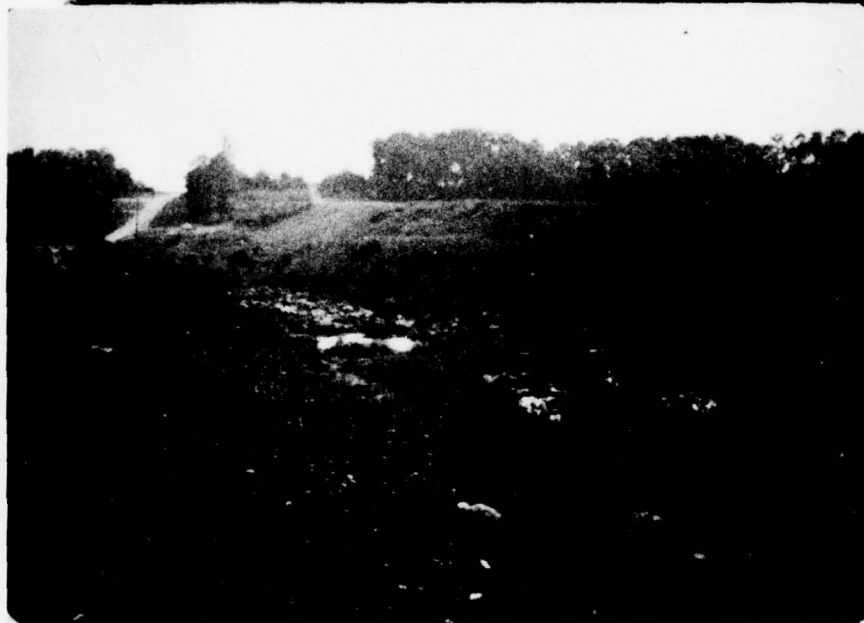
The capacity of the chute appears to be adequate for the top-of-dam weir discharge of 7,400 cfs but it is recommended that the conveyance of the chute be maintained by removing the brush.

Spillway Channel

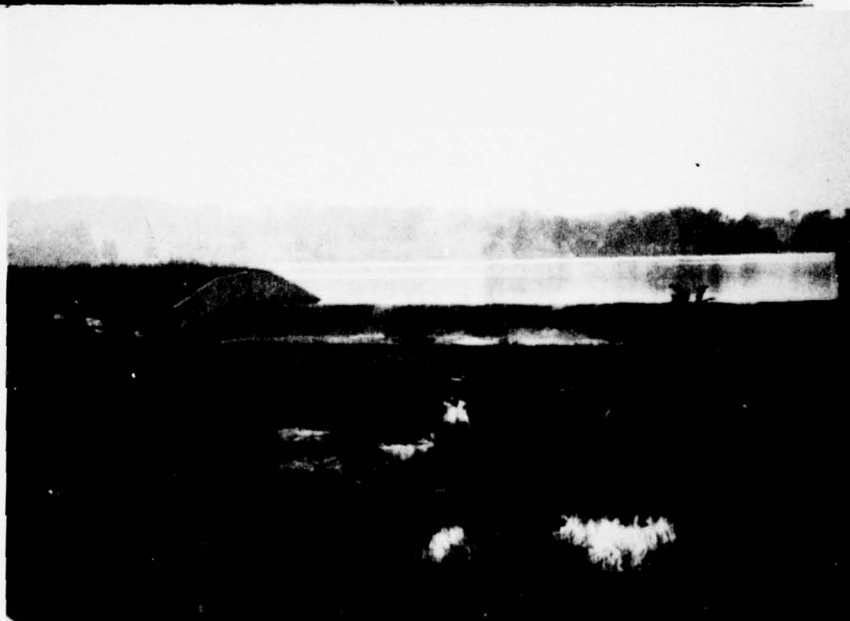
Spillway Weir

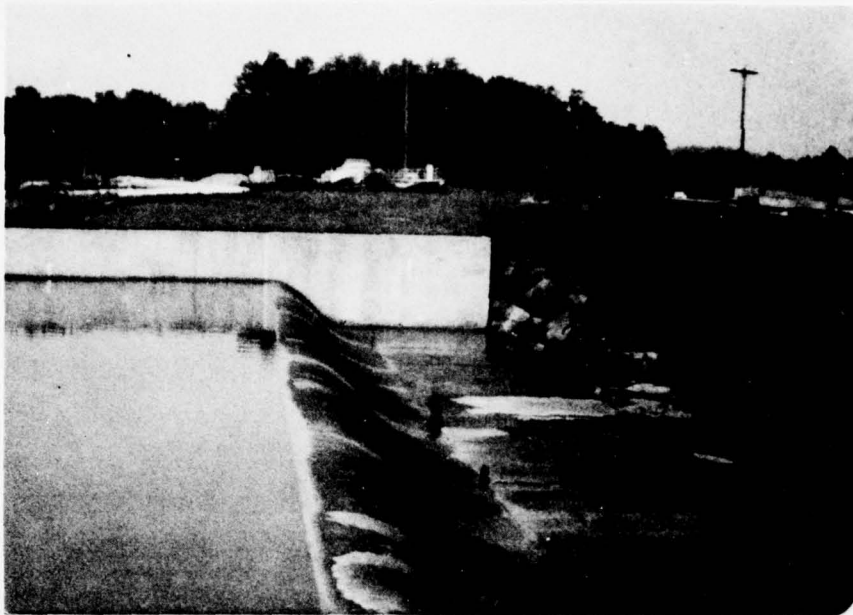
Spillway Weir

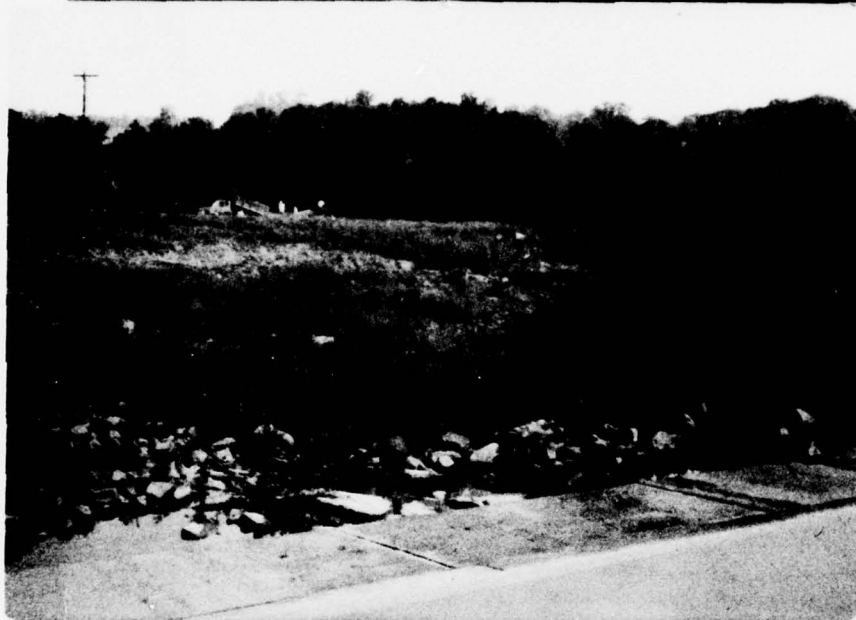
The spillway weir is located near the left abutment. The concrete weir and retaining walls were in good condition. Some minor cracking has occurred in the slabs below the weir. It appears that the slab was poured on rock and if the cracks do not widen, no future problems are expected. At the end of the spillway slab a large part of the downstream cutoff wall is exposed. The placing of large boulders should be recommended to prevent undermining of this slab. Most of the long spillway chute is excavated in rock and unlined. The rock appears to be hard. The chute makes a 90-degree right bend close to the spillway and then parallels the toe of the embankment over a length of 1200 feet. Possible erosion could occur opposite the weir where the channel makes the bend, but this would not affect the safety of the structure.

The visual inspection of the spillway, spillway chute and valve box did indicate that all structures are in good condition. There was no excessive cracking, spalling or deflection in any of the structures. The deep exposure of the downstream cutoff wall of the weir would indicate the need of placing some heavy stone in this area.

Downstream
Apron Spillway

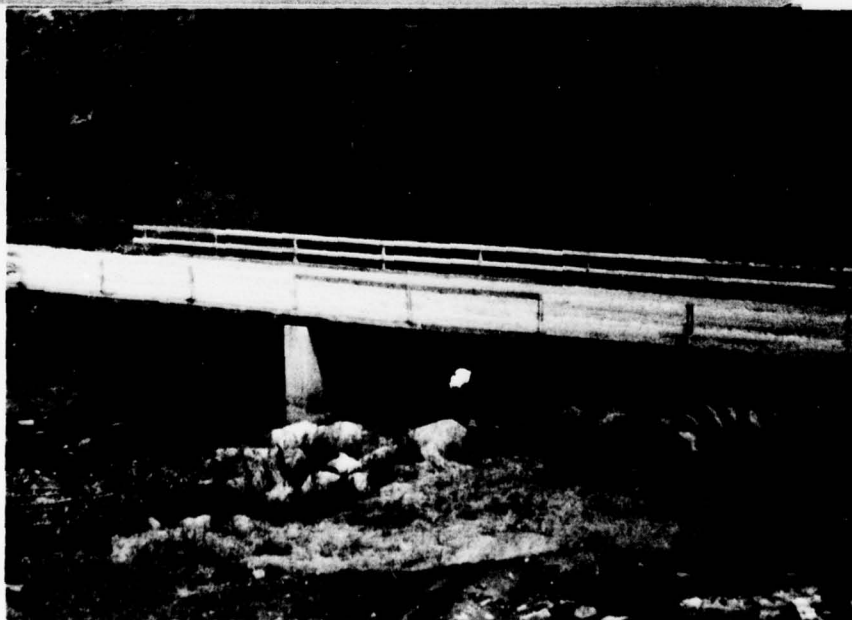
The downstream channel is a natural stream channel and passes underneath a bridge about 300 feet below the centerline of the dam. The stream is rather small and has heavy brush and tree growth on its banks. The stream meanders through a mostly agricultural area and joins the Bermudian Creek approximately 7.0 miles downstream from the dam. Only one house is located close to the stream and the hazard category is considered to be "Significant".

Downstream
Bridge
